**Flood Control Project Maintenance  
Levee Inspections**

**Fall 2012 Levee Maintenance Deficiency Summary Report**

**Sacramento River Basin**

**Knights Landing Ridge Drainage District**

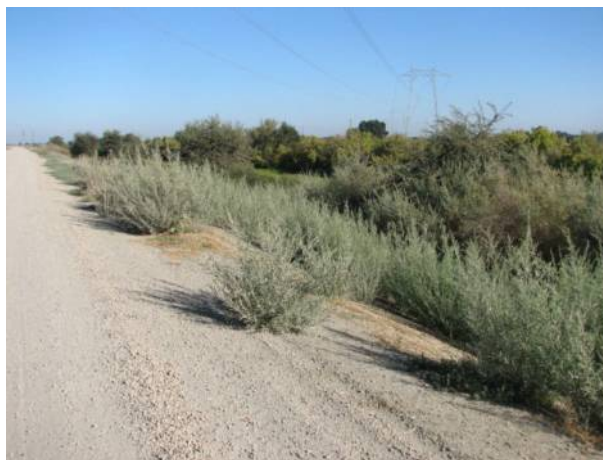
Levee Mile Report Line	4
Start Levee Mile	1.54
End Levee Mile	1.54
Location	Water Side
Category	Earthen Levee
Item	Vegetation

Sandbar Willows are creeping up waterside slope. Fall 2012

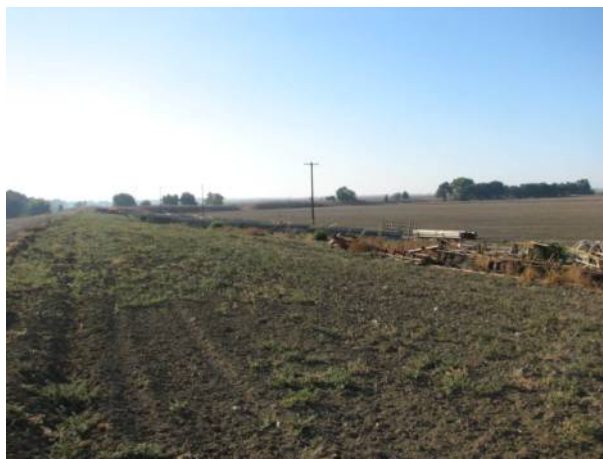
Levee Mile Report Line	8
Start Levee Mile	6.17
End Levee Mile	6.41
Location	Land Side
Category	Earthen Levee
Item	Encroachments

Equipment and irrigation pipe along the slope of the landside levee. Fall 2012

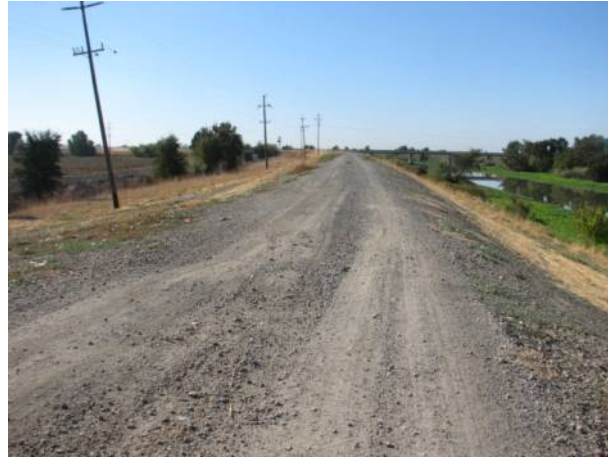
Levee Mile Report Line	1
Start Levee Mile	2.53
End Levee Mile	2.53
Location	Crown
Category	Earthen Levee
Item	Slope Stability

There is some settling of the levee crown. Fall 2012

LMR No.	Levee Mile		Category	Item	Location	Rating	Action/Comment	GPS Latitude/Longitude		Issue No.
	Start	End						Start	End	
1	2.53	2.53	Earthen Levee	Slope Stability	CR	M Ma	S1 : Repair slope instability.	38.751823 ° -121.692795 °	38.751823 ° -121.692795 °	8 Y
								DWR ID: DWR_NA0008_02_f_2012_8		
2	2.72	2.72	Supplemental	USACE Erosion Survey	WS	M Ma	Inspector Comments: 2006 - The whole levee toe area is slowly slumping into the channel (creep) due to dewatering and poor slope soils. Occasional piping in the levee slope evident as well. Pistol-butted trees at the levee toe indicate slow retreat. 2011 - Multiple scallops throughout the site and slumping of the toe. 2012: Site is part of the extended inventory, last inspected 2011. [2012 Site ID: KLR_3-0_L]	38.757925 ° -121.693048 °	38.754899 ° -121.692653 °	2
								DWR ID:		
3	3.01	3.01	Supplemental	USACE Erosion Survey	WS	M Ma	Inspector Comments: 2006 - The whole levee toe area is slowly slumping into the channel (creep) due to dewatering and poor slope soils. Occasional piping in the levee slope evident as well. Pistol-butted trees at the levee toe indicate slow retreat. 2011 - Slumping of the levee toe. 2012: Site is part of the extended inventory, last inspected 2011. [2012 Site ID: KLR_3-1_L]	38.760053 ° -121.694686 °	38.758587 ° -121.693359 °	3

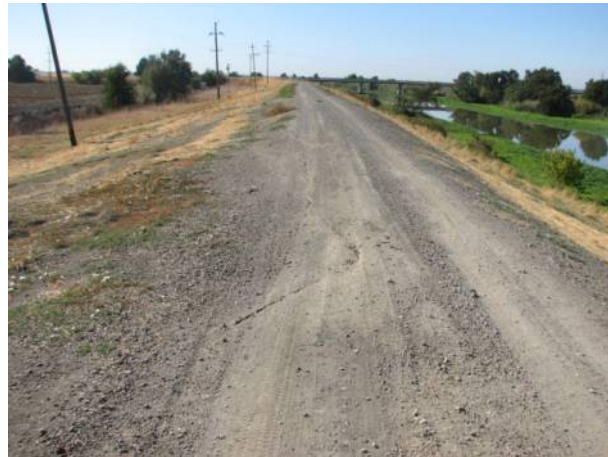
Levee Mile Report Line	1
Start Levee Mile	2.53
End Levee Mile	2.53
Location	Crown
Category	Earthen Levee
Item	Slope Stability

A crack where the crown is depressed. Fall 2012

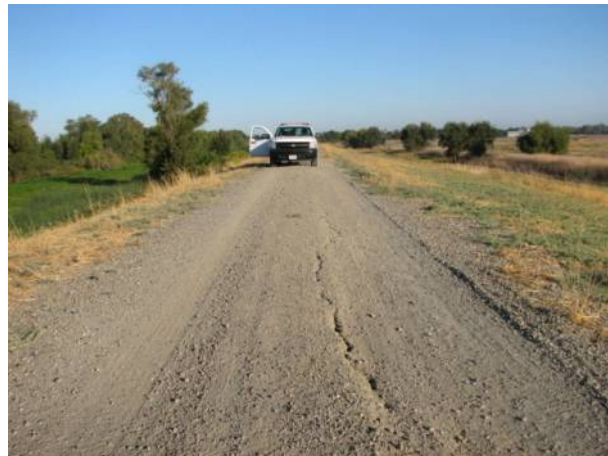
Levee Mile Report Line	6
Start Levee Mile	5.21
End Levee Mile	5.21
Location	Crown
Category	Earthen Levee
Item	Cracking

Some cracking and sluffing on the crown. Fall 2012

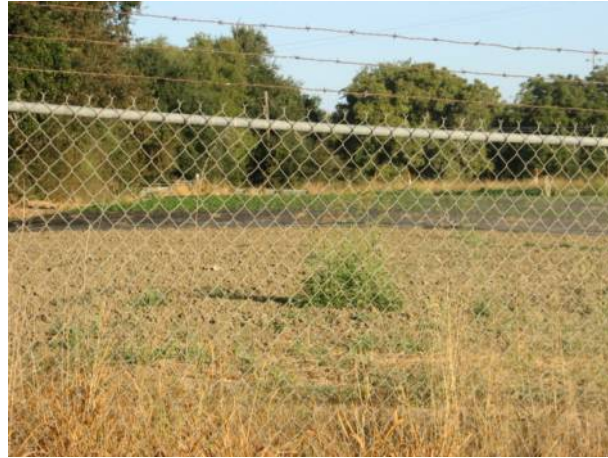
Levee Mile Report Line	8
Start Levee Mile	6.05
End Levee Mile	6.12
Location	Land Side
Category	Earthen Levee
Item	Encroachments

A current view of the strawberry patch. Fall 2012
